Study of deterioration of ancient brick monuments -a case study at Polonnaruva

Arjuna Thantilage¹ W.M.S.R. Ratnayake² Nalin Cooray³

Introduction

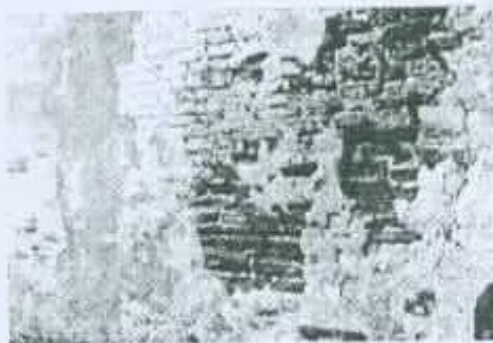
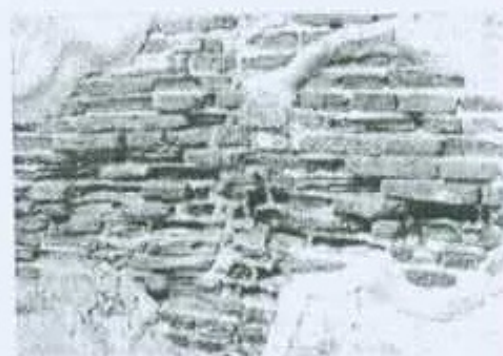
fig.1

In this process, the clay particles of outer surface of the bricks gradually get detached resulting in the wearing out of the bricks leaving concave coarse surfaces. But this process happens both on the mortar and on the bricks at almost the same rate (fig. 1 and 1.1). This deterioration process could

be seen restricted to the patches, which were mostly located 1.0 m - 1.5 m over the ground level. The detached powdered brick and mortar particles could also be seen

deposited at the bottom of the cavities formed due to this deterioration, confirming the on going process (fig. 2). It is important to note that the bricks underneath the

layer of powdered brick and mortar particles (about 1 mm-2 mm thick) seem to remain intact. In some patches of affected brickwork, it can be seen that the cavities extend deep into the wall affecting its stability. There is more danger of having this damage in the cavities on wall surfaces of the Parakramabahu Palace, where the structural timber framework was originally embedded into the brickwork. This damage can also be seen to a lesser extent inbetween brick pilasters and in newly restored brickwork at Tivanka Image House (fig. 3 & 4).

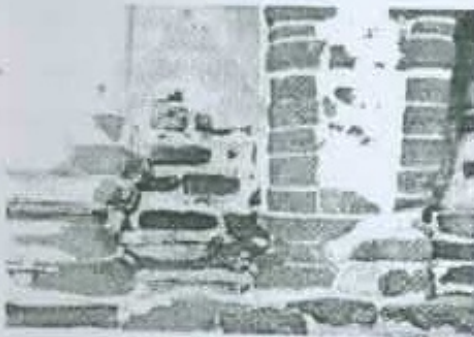
fig.4

both at the Lankatilake and Thivanka Image Houses. As a result of this damage, most of the fine details of the decorated wall surfaces are being worn out leaving rounded surfaces (fig. 4 & 5).

Figure 4 shows the bricks close to each other on exterior wall surface at Tivanka Image House that have been affected by both deterioration Type 1 and 2. In this case, deterioration Type 1 is active on isolated bricks. Plaster on such bricks has already disappeared, and the exposed brick surfaces continued to be worn out creating concave surfaces. This clearly indicates that deterioration Type 1 is a result of inside

force (i.e. salt crystallization within the pores) rather than an outside force, such as wind. In this case, the wind performs only a supportive role to enhance the evaporation of moisture within the bricks, thus creating a super saturated solution, and then accelerating the removal of loosely bound particles present on the brick surface.

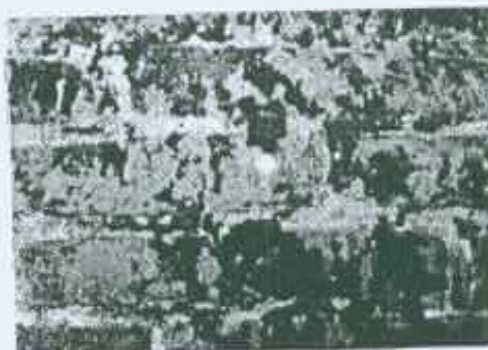
fig.6

External white patches about 1 cm -2 cm in diameter on brick surfaces were the main

visual observation of this damage. These white patches could be easily removed with scraping. When removing each selected white patch, a small hole, leading deep into the brick wall could be observed (fig. 6). The diameter of the hole increases

from the exterior surface towards the interior of the brickwork. This damage could clearly be attributed to the activities of a particular insect, since both sack (puparium)

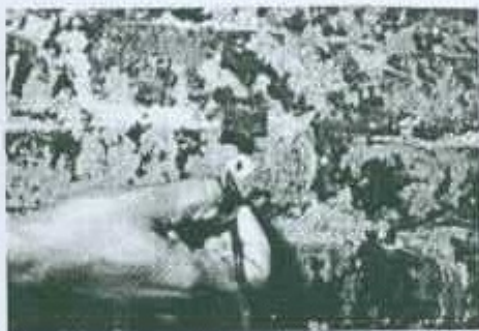
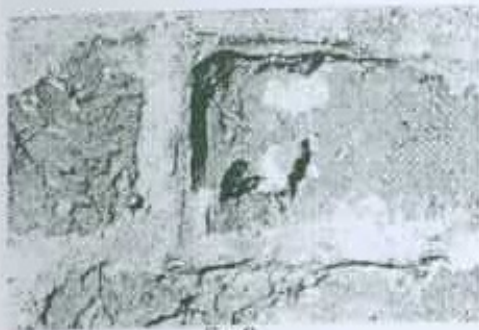
and dead insect larvae were found inside almost all the inspected holes. (Figs. 7, 8 & 9).

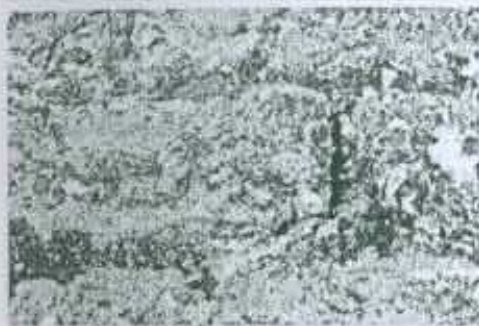
fig.10

In addition to the above main deterioration processes, several moss and lichen growths on several areas could be seen in all three monuments, specially on the shaded areas of the Tivanka Image House. (fig.10).

In addition to the above identified deterioration processes, growth of moss and lichens can also be seen on the wall surfaces. This may also contribute in a small scale to the deterioration of fine details on the brick surfaces.

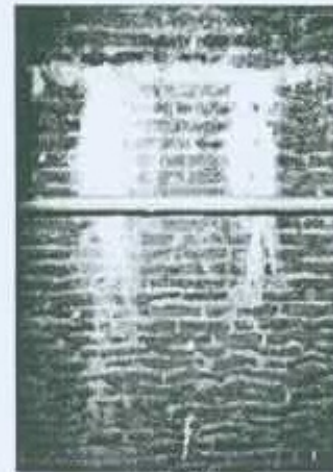
fig.9

can also be seen associated with the damaged areas of the new brickwork (fig. 9).

Deterioration Type 1 is also seen in the new brickwork on the restored sections of Tivanka Image House. Efflorescence has also been observed above the bricks that are affected by deterioration Type 1. During the recent restoration work, bituminous tar sheet has been laid on the interface of the new and old brickwork and efflorescence has occurred at this brick - tar sheet interface. This efflorescence problem is due to thick mortar joints and usage of high proportion of cement and lime as the constituents of mortar as the unbind cement and lime have increased the amount of soluble salt content and movement of the ions.

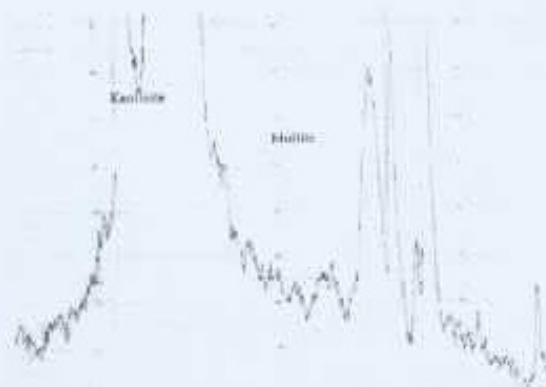
Table: 2 XRD graph for sample PB 1

- (1) All major peaks of both samples are from kaolinite.
- (2) A small peak (compare to major peaks) correspond to mullite was observed in both XRD patterns.
- (3) Other minerals are in small quantities and cannot be identified due to high intensity of kaolinite peaks

XRD analysis shows the presence of mullite minerals, having an orthorhombic crystal structure in both the damaged and undamaged brick samples. Mullite is formed only at high temperatures (Deer 1966, 37) and availability of mullite indicates that both damaged and undamaged bricks are properly burnt. This emphasize that this deterioration is not due to inferior burning of bricks.

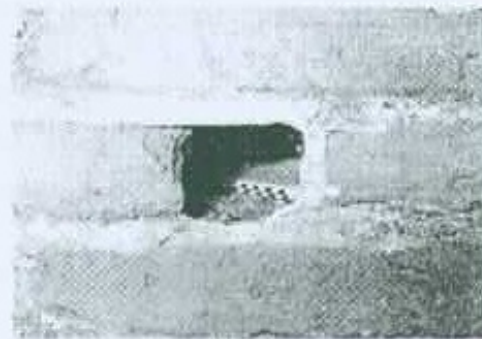
fig.11

This damage can be clearly attributed to a particular insect. Although the effect of this process is relatively low at present, it could subsequently initiate further deterioration (fig. 11). This biological factor needs to be studied in detail to arrest the deterioration process.
